Toroidal Transformer – Mounting and Failure Possibilities

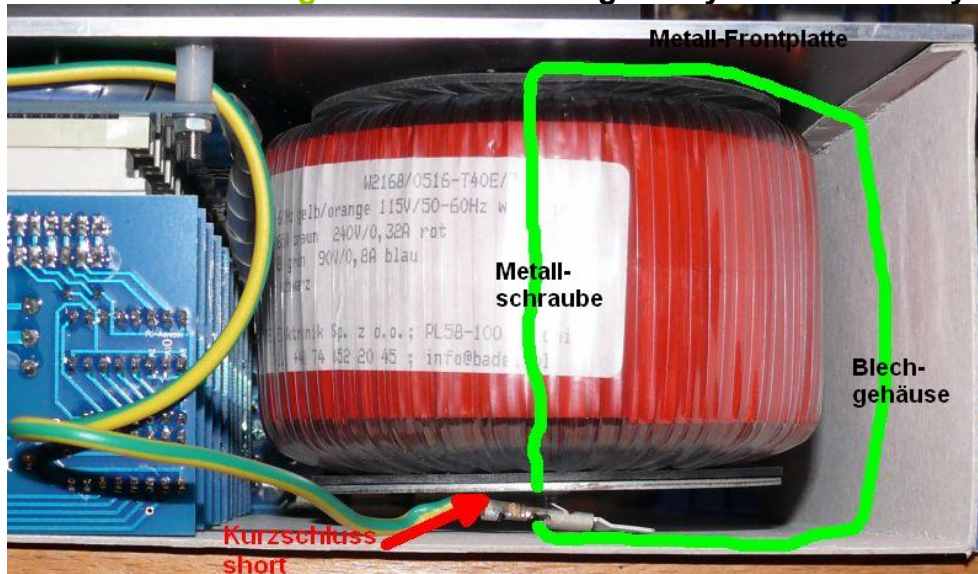
Neither the metal sheet nor the upper end of the transformer's mounting screw may touch any parts of the metal housing or protective ground.

This would create a shorted winding through the transformer causing a large current flow in this shorted winding.

I encountered the following problem: When I connected the metal housing to the protective ground with a 6,3 mm flat connector below the transformer that connector touched the transformer's metal sheet. This led to a **shorted, very low-resistance transformer winding**. The transformer got very hot without any load applied.

Put a piece of heat shrinkable tube over the connector to achieve sufficient insulation:

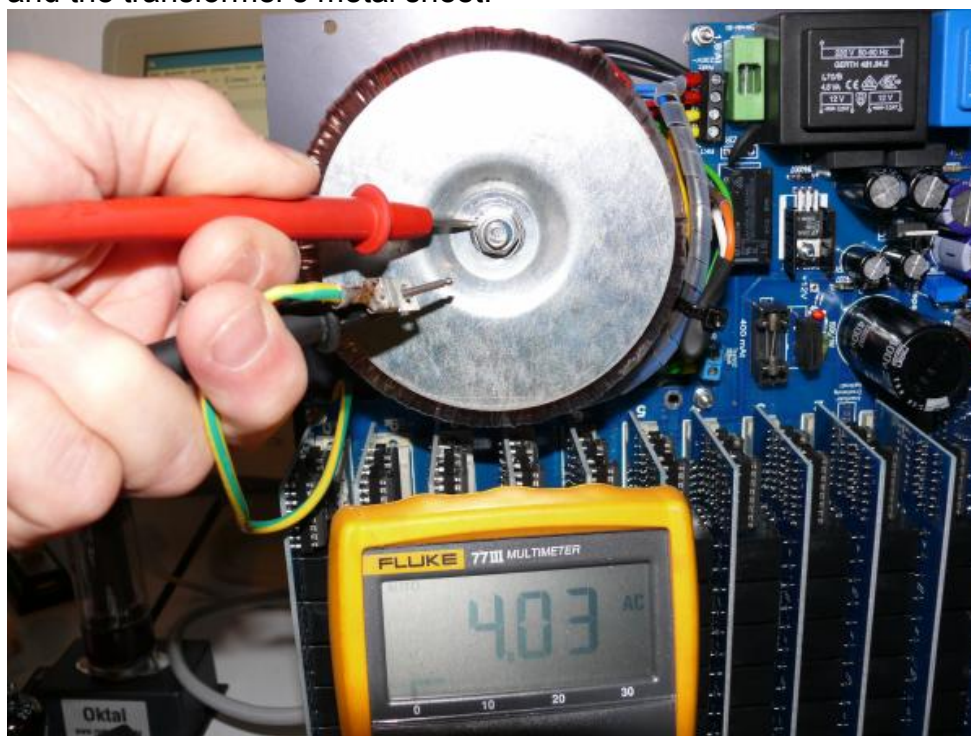
You can easily prove that there is a high short circuit current flowing when you connect an ammeter between the metal housing (or the attached protective ground) and the transformer's metal sheet:

In this case a current of 4A was observed. Without the long measuring cables - with the solid metal housing as conductor – the current path will probably have much less resistance and the current will be even higher.
